# Electronics related to BEC report

Feng Gao  
weekly meeting  
2023-03-07

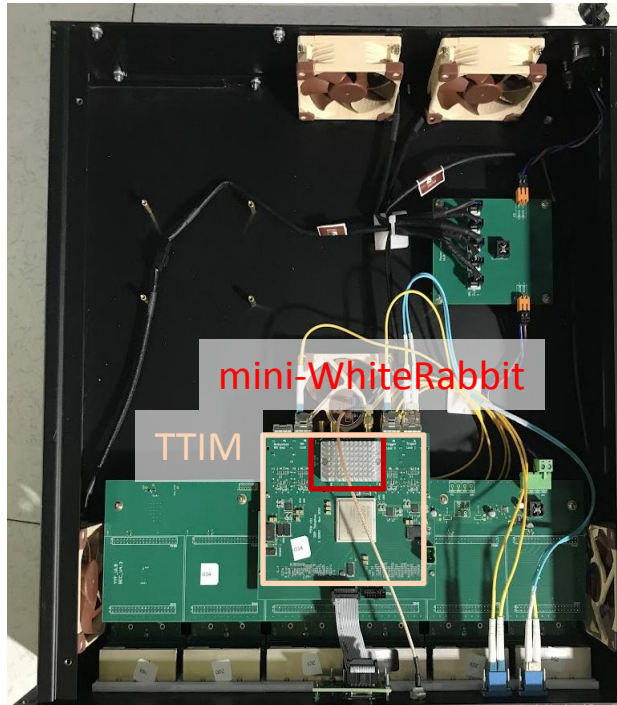
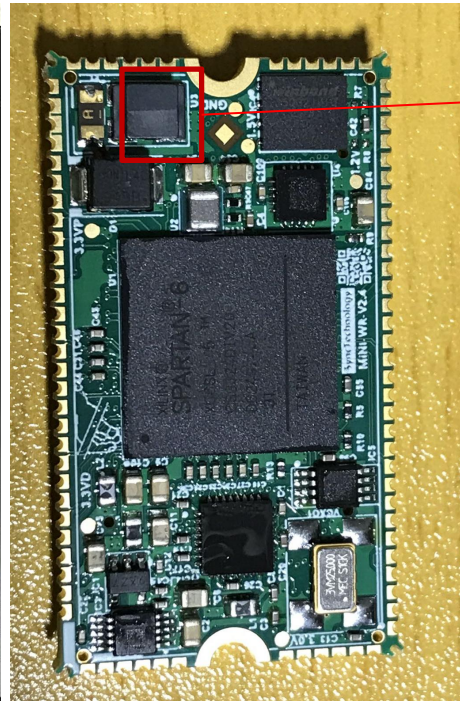
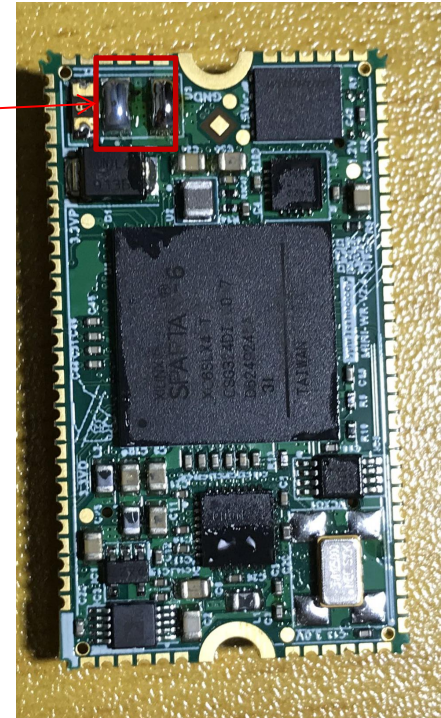
- mini-WR module issue: communication between PC and TTIM.

- for some TTIM/BEC, clock can't lock by mini-WR when transfer large data.

The mini-WR produced a large voltage drop when the common mode(CM) choke processing the network packet. From oscilloscope there is a voltage fluctuations.

- by removing the CM choke, no packet loss, no clock not lock.

After removing the heat sink of mini-WR, remove the common-mode choke coil and short-circuit the power supply pins together.

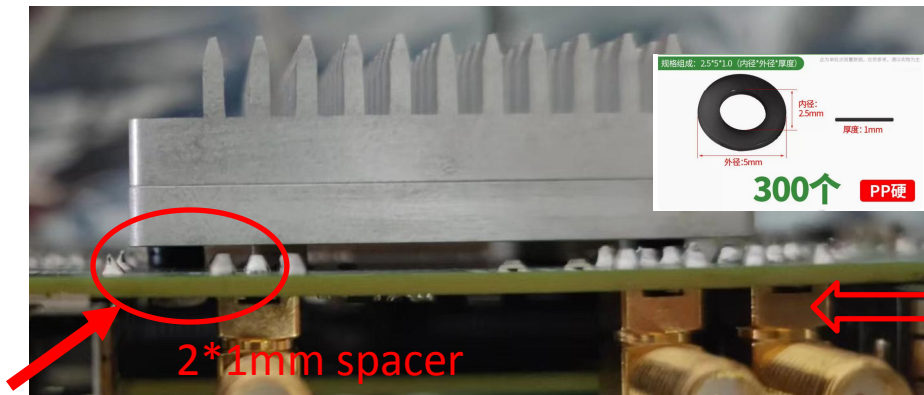
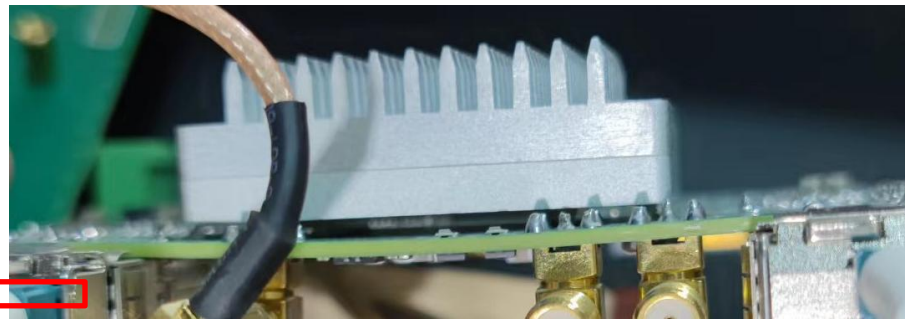
- WR-repair reviewing : 2023-04-07
- remain problem:
  - screw between TTIM and base board is too tight make the board bending.
  - prbs error during loop test after last repair due to the board bending. loosen the screw, BEC pass the test.
- solution: put spacer on screw

- WR-repair reviewing : 2023-04-07
- repair plan:
  - for the repaired BEC(mini-WR) last time
    - open the box, put space between TTIM and mini-WR.
  - for the BEC(mini-WR) has not been repaired, open the box,
    - open the mini-WR, remove the common choke and the fuse next it. only one BEC(backup from kunshan)'s fuse is removed.
    - put space between TTIM and mini-WR.
- test plan: loop test for all repaired BEC
- note: only BEC in SAB/storage(9) not repaired from 7thApril.

- Jianmen repaired at 2023-04-18
  - how:
    - open BEC box, loose TTIM from base board, loose mini-WR board from TTIM.
    - put space between TTIM and base board, install them back.
  - how many repaired?
    - EleRoom 1 is finished at 2023-04-18 by worker(安得远通) with Jianmen's 'supervisor'
    - EleRoom2 is finished at 2023-04-19 by worker(安得远通)
- test situation
  - ping+ Temperature reading is done.
  - loop test not yet, will done at least before the installation.
