Status of the BEC

> JUNO EU meeting 2023-05-10

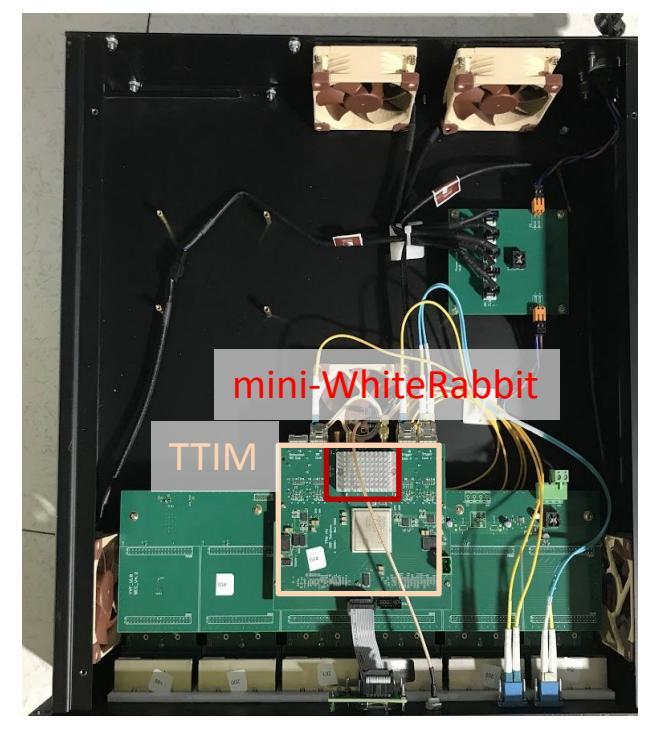
Communication problem between WR switch and TTIM; it was found last year during the BEC test in eleRoom. For some TTIM/BEC, clock from mini-WR may lose locking when large data is transferred.

- The common mode (CM) choke produce a large voltage drop when the mini-WR is processing the network packet.
- Solution: removing the CM choke, no packet loss, no clock got unlock.

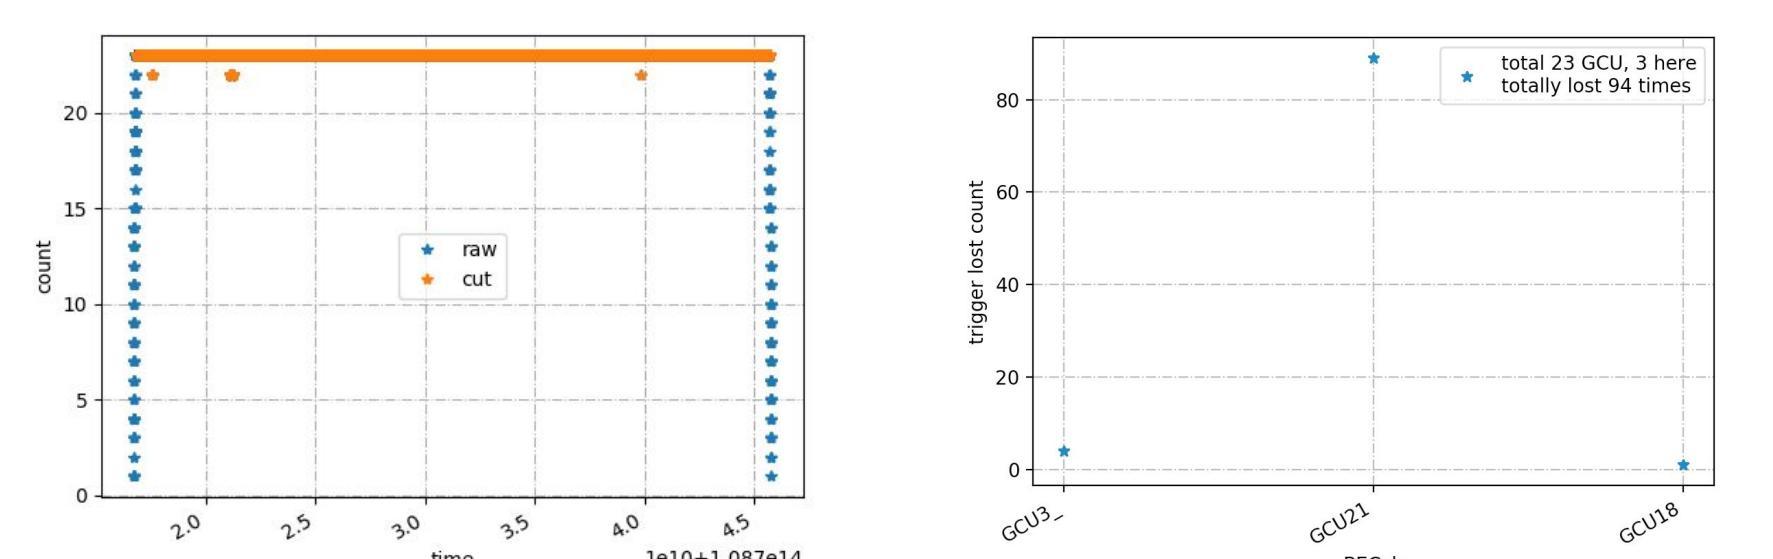
- for example Run7866/BEC 47, at one time, it should have 23 triggered GCUs.
- if not :
 - \rightarrow GCU didn't receive trigger
 - \rightarrow DAQ lost data

The drop of two ends are due to the non-parallel launch order of the DAQ: not for analysis.

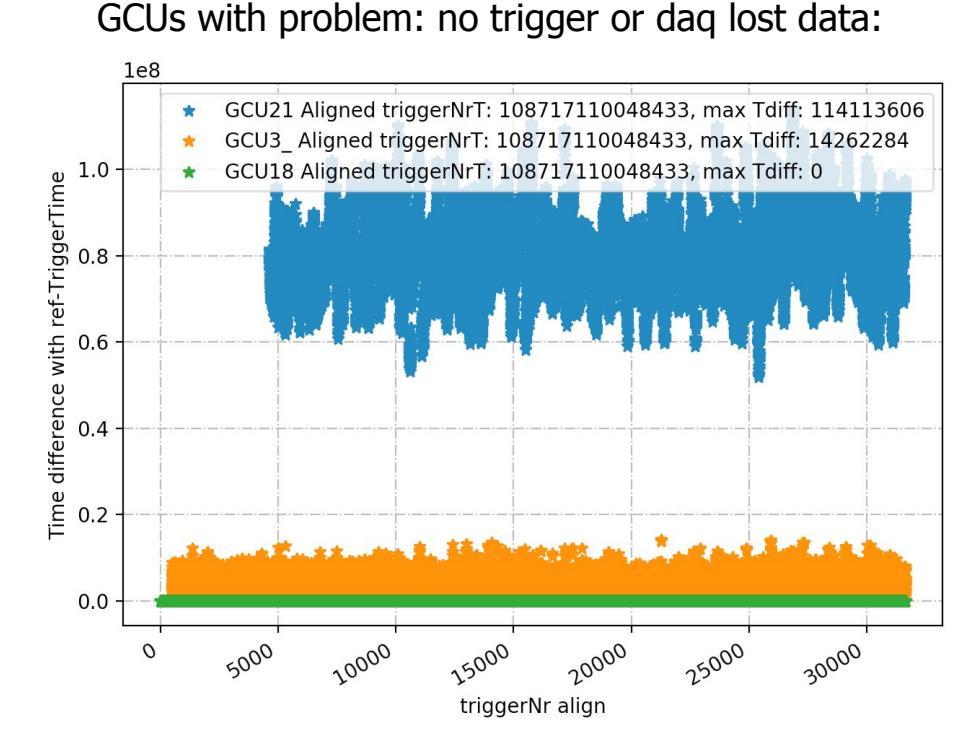
- a) Align all GCU's trigger time, pick this time's local triggerNr as 0th Trigger.
- b) Compare the GCU which lost data with ref-GCU.

- 1. if max Tdiff >0 , means GCU didn't receive trigger at least once.
- 2. if max Tdiff=0, means DAQ lost data

GCU21 and GCU3 didn't receive trigger at least once. GCU18 DAQ lost data.

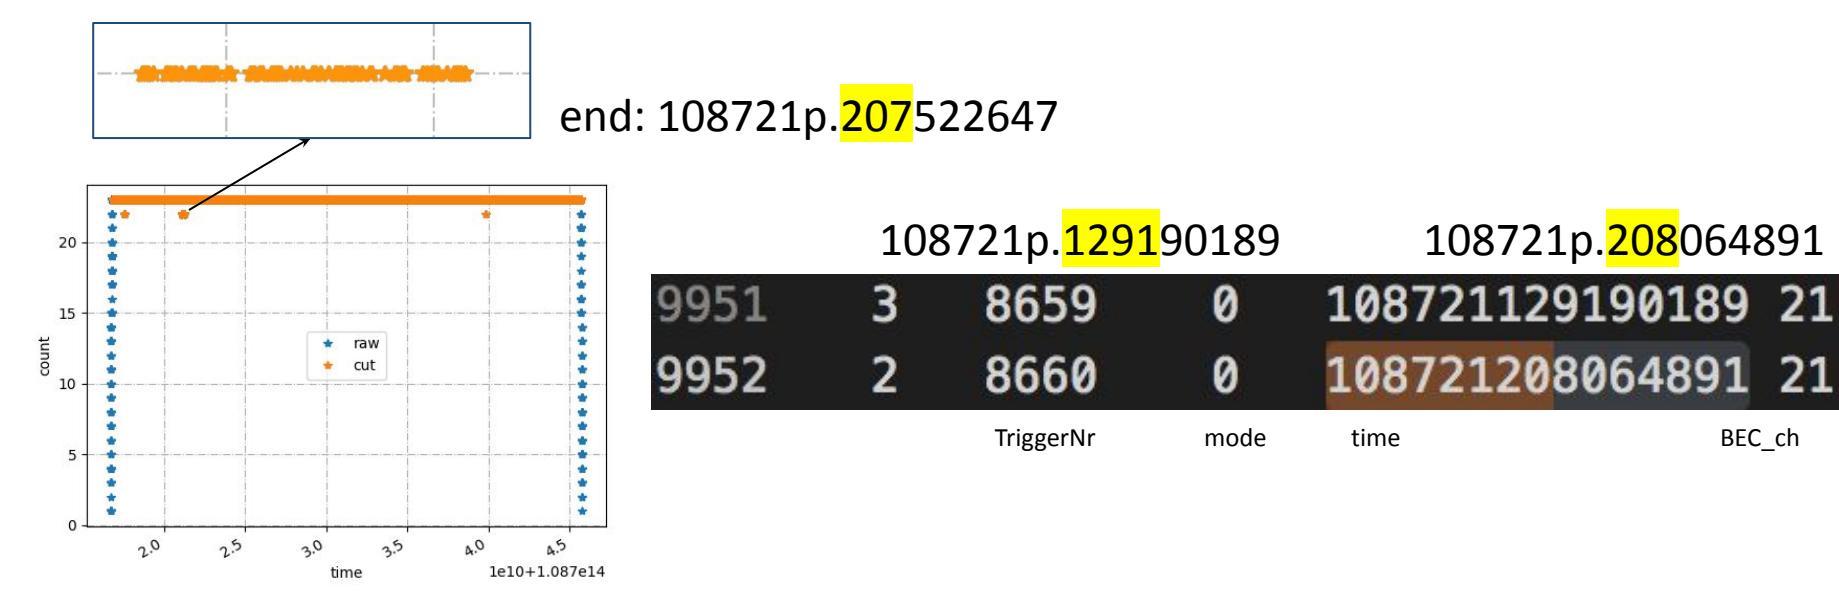
check timestamp of all GCU(23) of one BEC, run 7866

BEC's 21st ch, trigger lost 89 times, during this time, GCU's local triggerNr is continuous. means: GCU didn't received trigger decision
