Final cleaning of the acrylic sphere

JIE ZHAO

2024-12-6

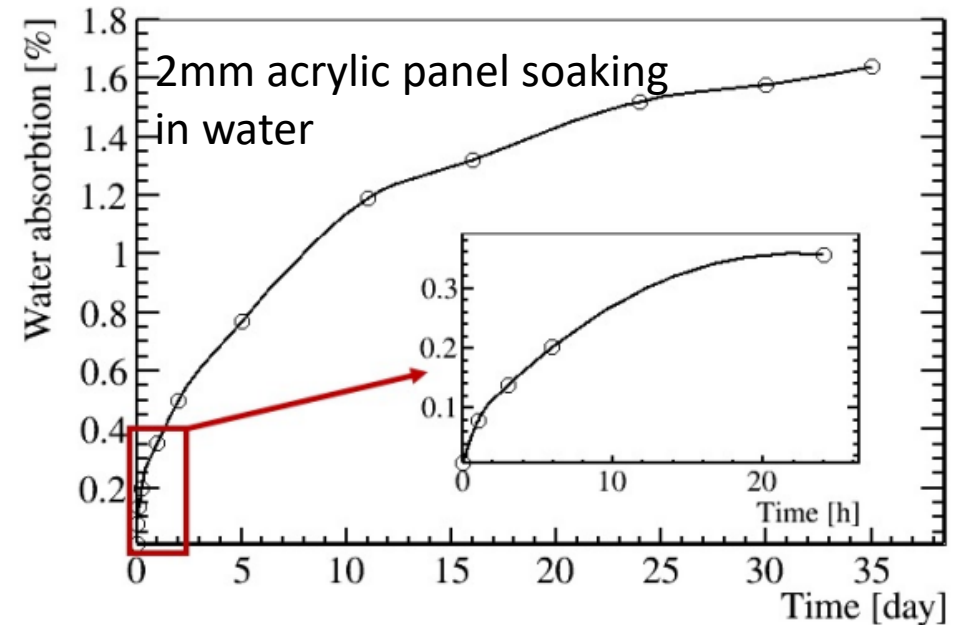
Experimental data:

- Since the radon in air inside the acrylic is 50 Bq/m³, the radon in water can reach ~10 Bq/m³ (for calculation)
- 2mm acrylic panel soaking in water for two months
- Based on the curve, water absorbed in acrylic for 6.6 days soaking is 19 g/m², totally 77 kg

- 10 Bq/m³ radon in water, acrylic absorbed 77 kg
- Assume all the radon daughters go into LS, will lead to 6e-27 g/g ²¹⁰Pb in LS
- Negligible

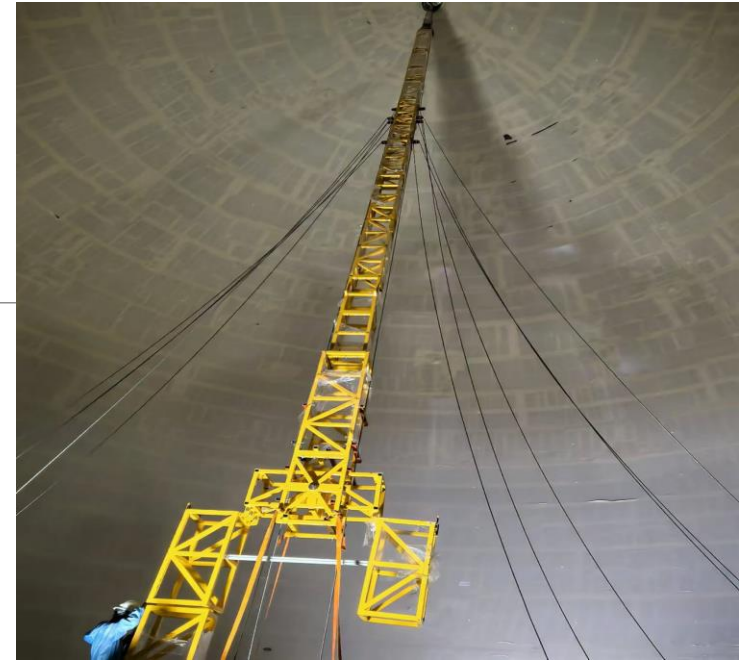
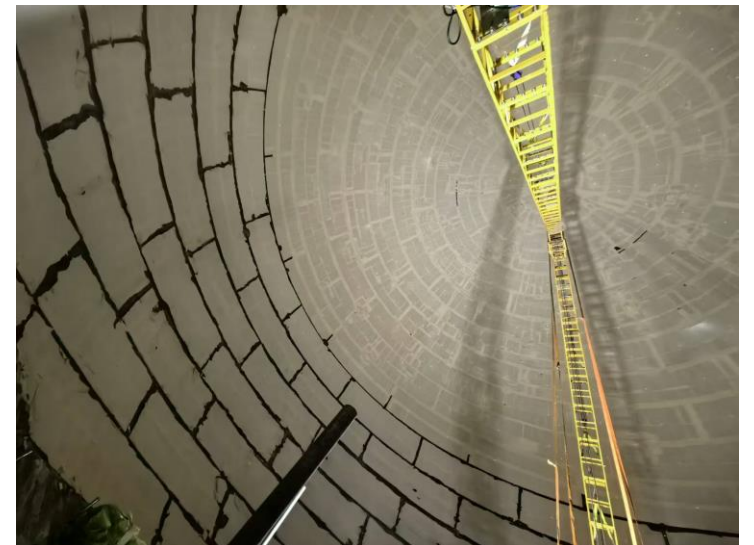
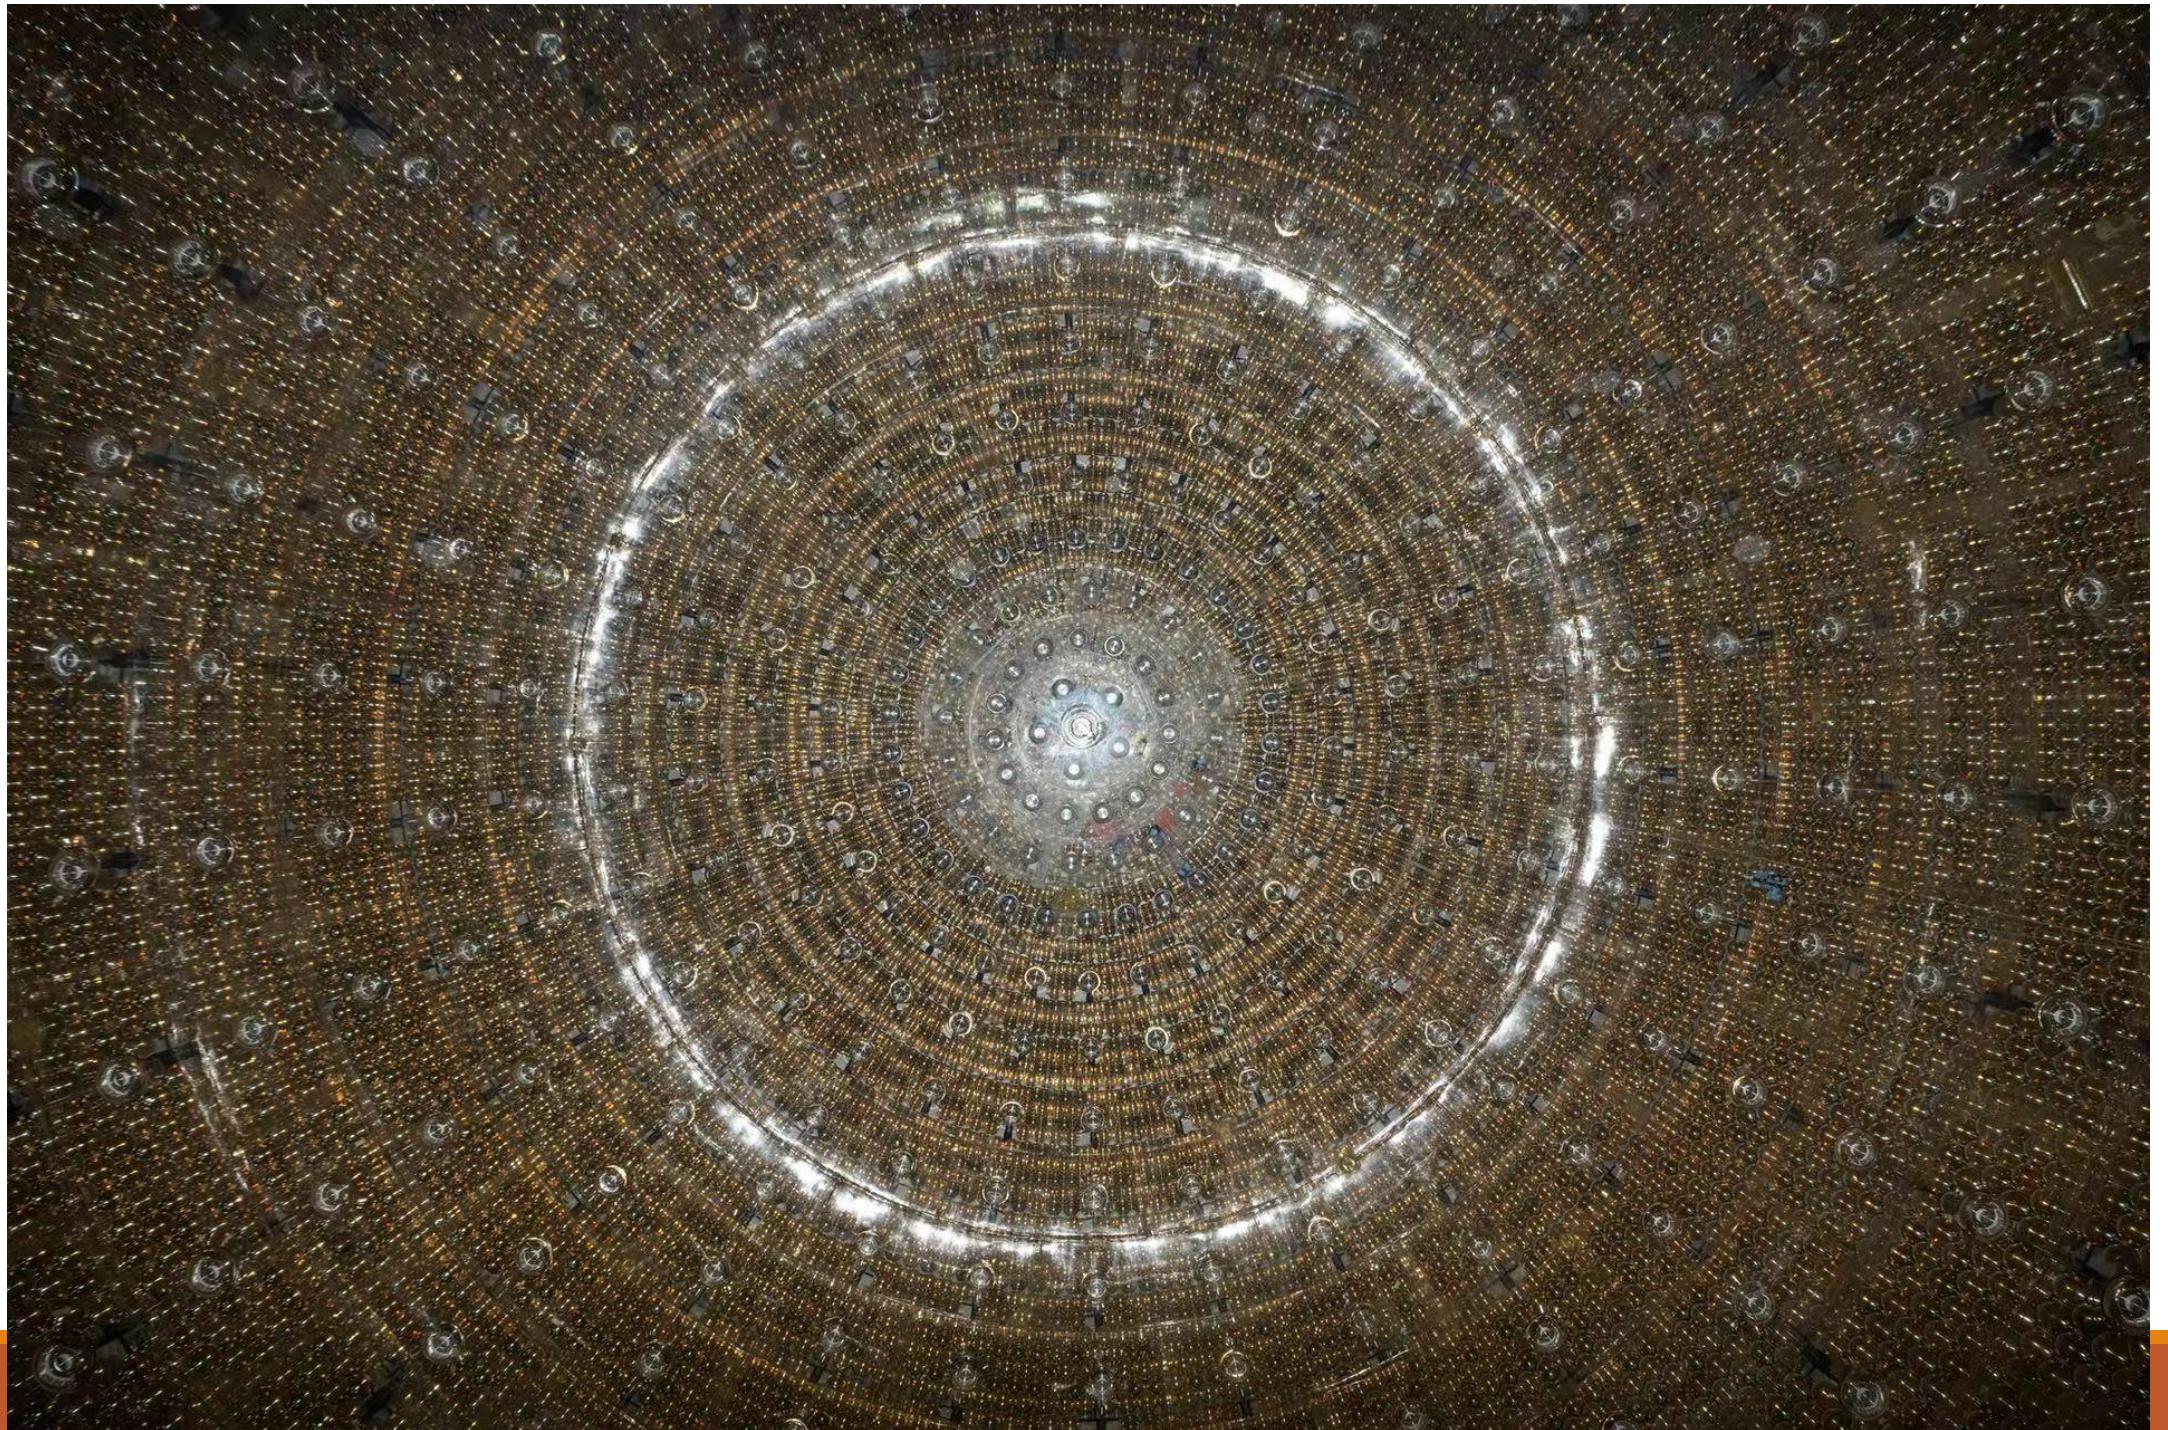
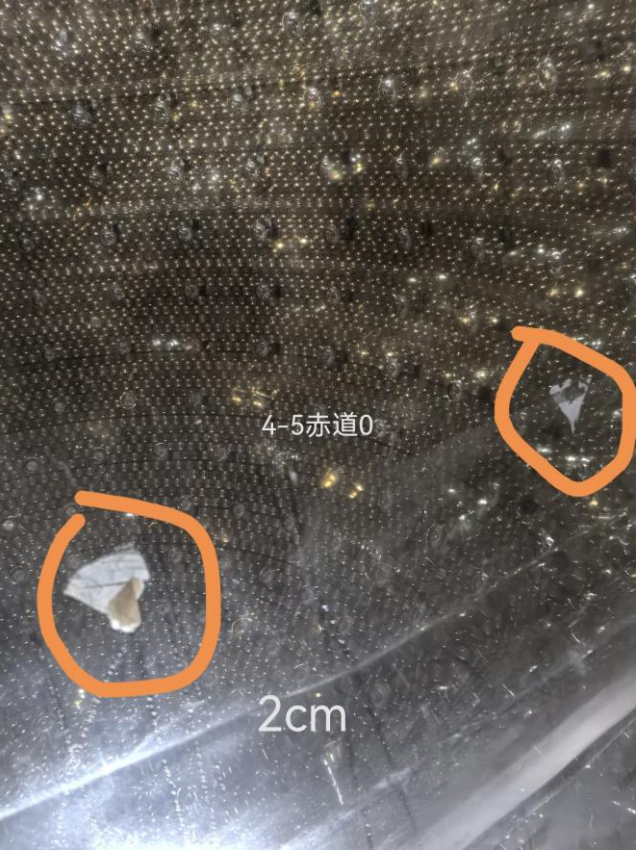
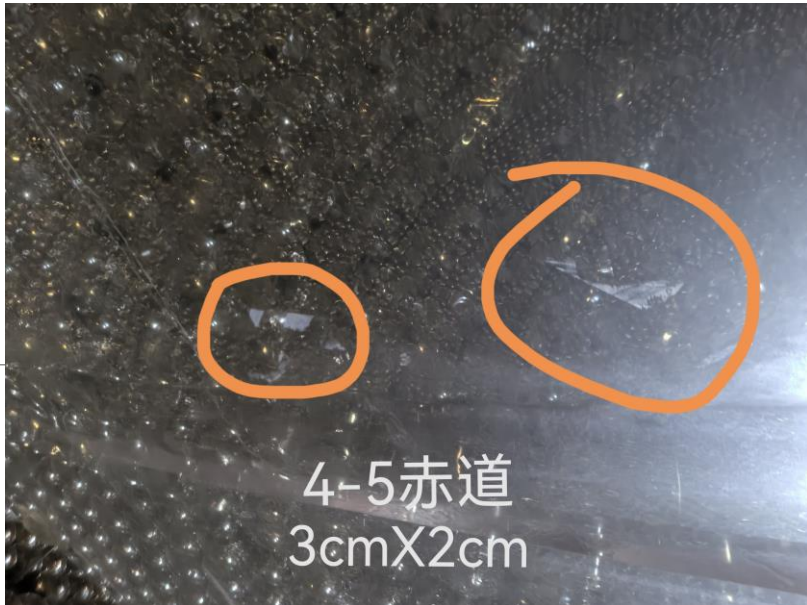
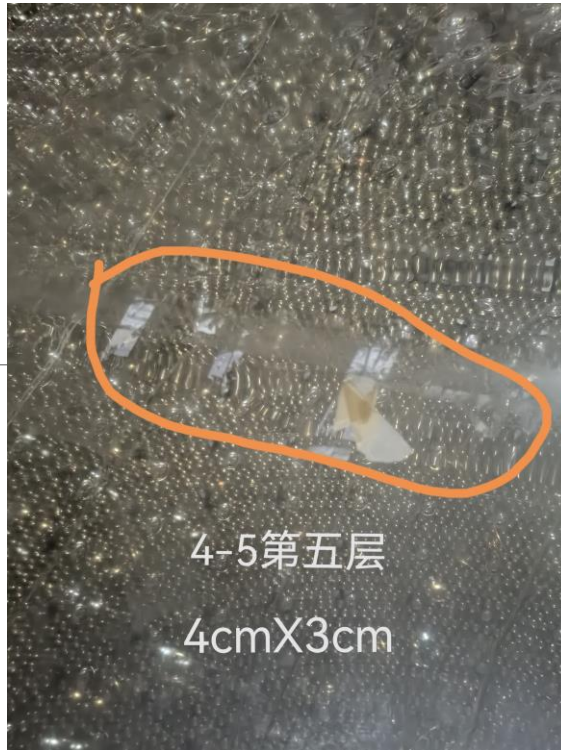
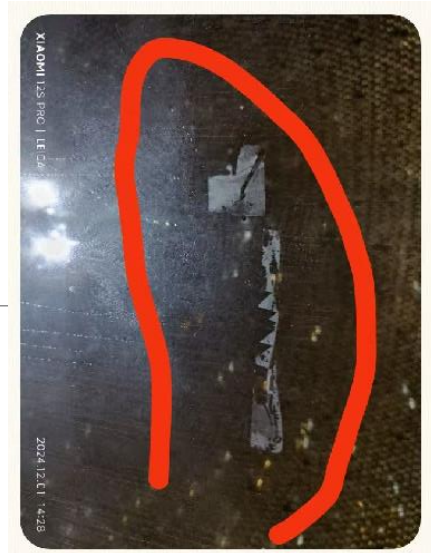
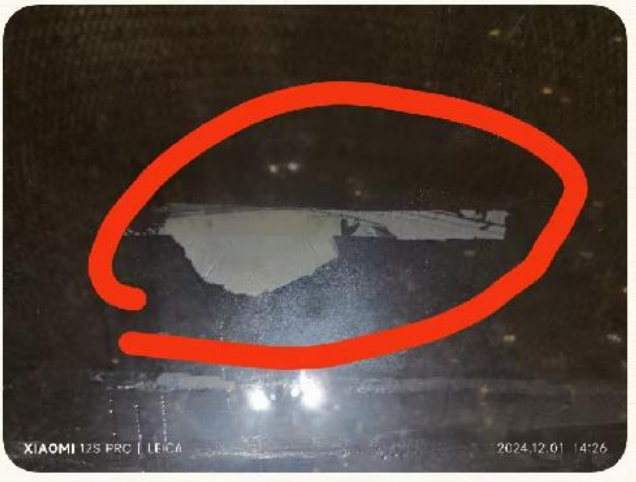
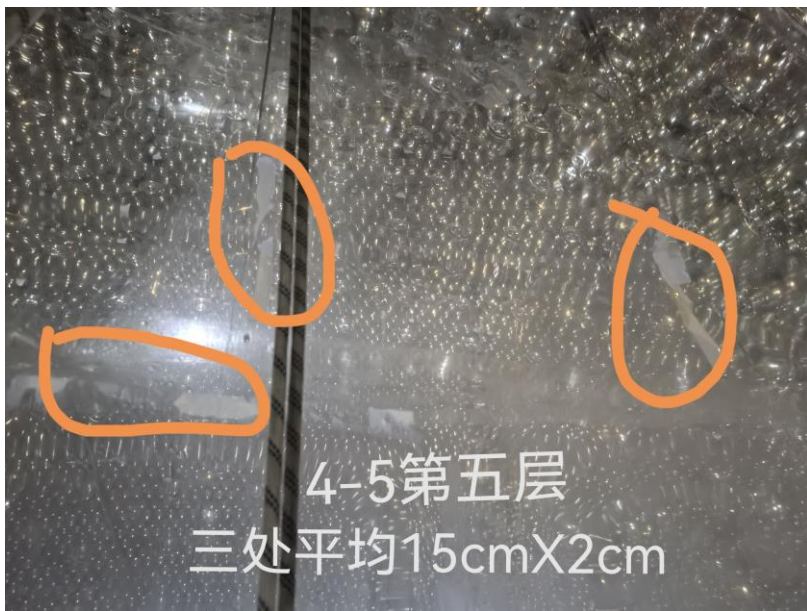
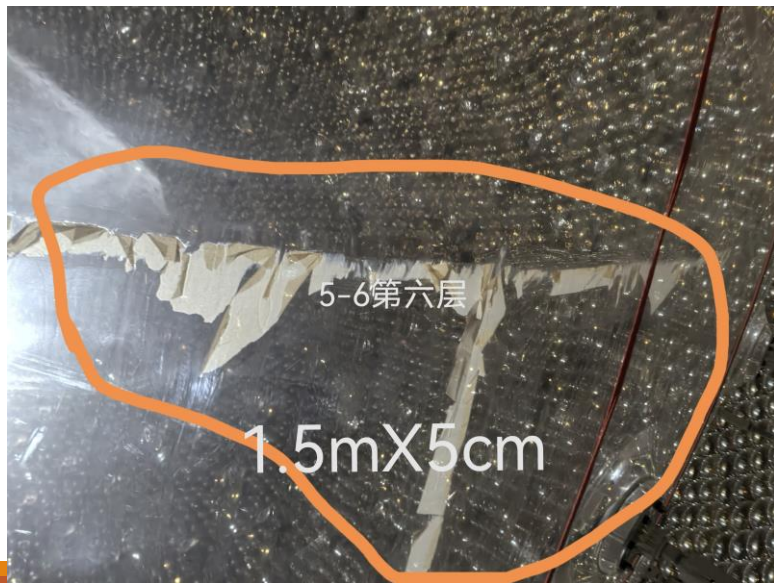
Most of the residual is on the bonding line with epoxy on the top hemisphere.

- All the paper film on the lower hemisphere bonding line are removed during the repairmen by the yellow structure
- However, the yellow structure can not go to top hemisphere, thus the paper film on the bonding line are not removed on the top hemisphere

Careful check by workers from Donchamp and firemen (above -2 layer)

- About 5-7 m² (0.15% of acrylic surface) by eye check, some pictures in next slide. The shape is not regular.

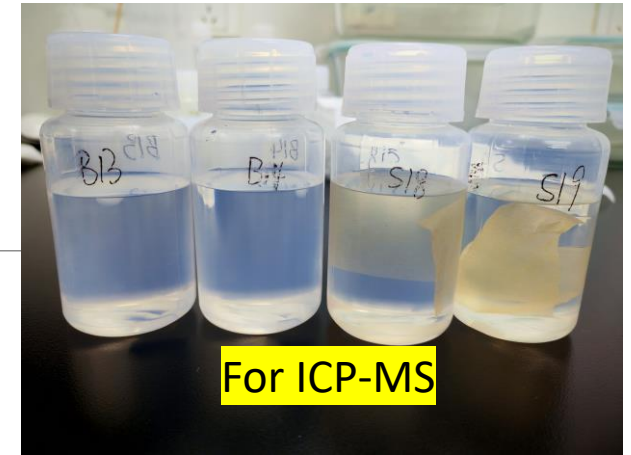
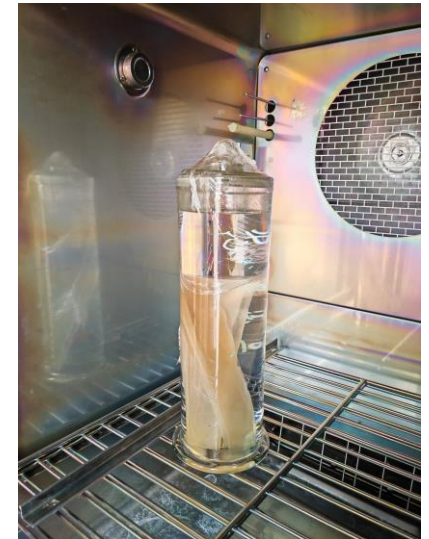
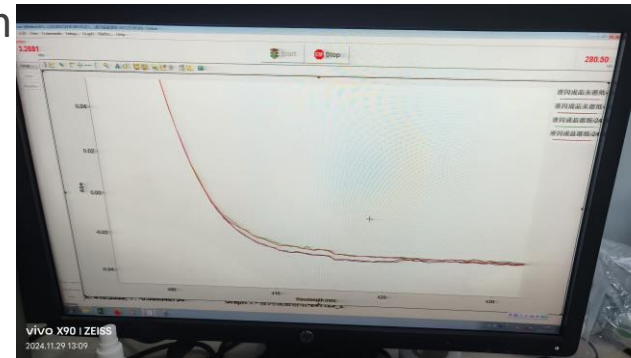
Background test

- Paper film soaked in LS at 80°C for 24 hours, which equals to 244 days soaking at room 21°C
- U/Th leaching from paper film: 2.3×10^{-20} g/g per m² per year → negligible

Compatibility test

- Paper film soaked in LS at 90°C for one week, which equals to 10 years
- No obvious change, the paper film will sink to bottom

Absorption spectrum test

- Paper film soaked in LS for 24 hours, no change on the absorption spectrum

- Residual paper film blocking 0.15%, no obvious effect on background, compatibility and absorption spectrum
